# model VRK5874

Valve Repair Kit

Model VRK5874 is a valve repair kit for Model 5874. Includes wave washer, cartridge regulator and 60 mesh strainer.

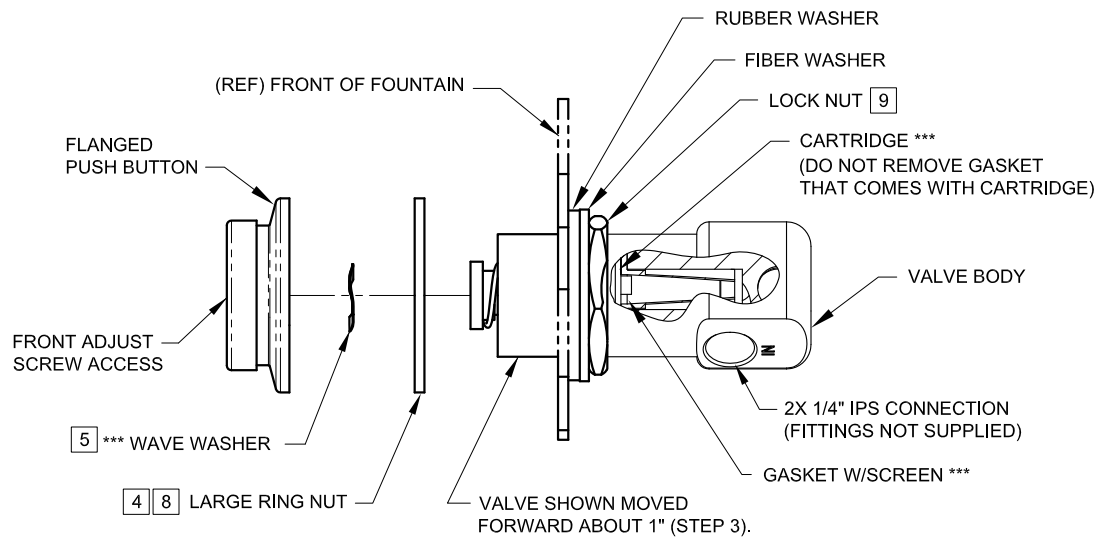
**INSTALLATION INSTRUCTIONS FOR 5874PBF OR 5874SS W/ PBA6**

\*\*\* MODEL VRK5874 - VALVE REPAIR KIT (INCLUDES THESE ITEMS) USED ON ALL 5874SS SERIES VALVES

- 1) FOLLOW INSTRUCTIONS CAREFULLY ON O&M MANUAL (PAGE 2 OF 6) WHEN REMOVING OLD VALVE. **NOTE: SEE PARTS BREAKDOWN (PAGE 4 OF 6) FOR ADDITIONAL NOTES.**

- 2) VERIFY THAT LOCK NUT, FIBER, AND RUBBER WASHERS ARE POSITIONED SLIGHTLY PAST MIDWAY OF THREADS ON NEW VALVE BODY.
- 3) INSERT VALVE INTO FOUNTAIN FROM INSIDE AND PUSH FORWARD ABOUT 1".

- 4) THREAD LARGE RING NUT ONTO VALVE BODY, APPROXIMATELY 1" INTO VALVE.
- 5) PLACE WAVE WASHER INSIDE OF FLANGED PUSH BUTTON ASSEMBLY (**MUST BE IN PLACE**).

- \*\*7) THREAD FLANGED PUSH BUTTON ASSEMBLY ON VALVE UNTIL WAVE WASHER MAKES SLIGHT CONTACT WITH STEM OF CARTRIDGE. **CAUTION: DO NOT HAND-TIGHTEN.**
- 8) UNTHREAD RING NUT FORWARD UNTIL IT STOPS FLUSH WITH PUSH BUTTON ASSEMBLY.

- 9) PUSH VALVE BACK TOWARD THE INSIDE OF FOUNTAIN AND TIGHTEN LOCKNUT (SEE ILLUSTRATION ABOVE).
- 10) TIGHTEN PUSH BUTTON ASSEMBLY USING UNIVERSAL SPANNER WRENCH PROVIDED.

\*\* OVERTIGHTENING WILL PRE-ACTUATE VALVE AND CAUSE WEEPAGE, WHILE NOT ENOUGH CONTACT BETWEEN WAVE WASHER AND STEM CAN CAUSE A LOW FLOW CONDITION.

**NOTE!**  
THIS VALVE IS PRESSURE COMPENSATING. BE SURE TO REMOVE ANY EXISTING FLOW CONTROL DEVICES. (MAY BE PRESENT IN FITTING OR SPUD).

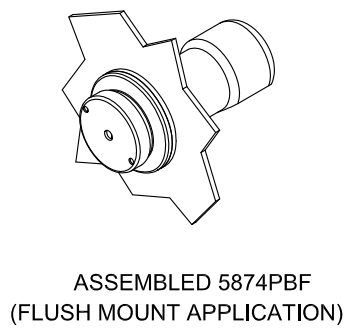
FIGURE 1

- 6) APPLY ONE (1) DOT OF LOCTITE 222MS, ON THE FEMALE THREADS OF BUTTON ASSEMBLY LEAVING THE FIRST AND LAST THREADS FREE. (FIGURE 1). **CAUTION: EXCESS LOCTITE CAN CAUSE THREADS TO LOCK VERY TIGHTLY, MAKING REPAIRS DIFFICULT.**

\* 6 APPLY 1 DOT OF LOCTITE 222MS (WHERE SHOWN)

\* THIS ALSO APPLIES TO PBA6

- 5) PLACE WAVE WASHER INSIDE OF PUSH BUTTON ASSEMBLY (**MUST BE IN PLACE**).
  - 6) APPLY ONE (1) DOT OF LOCTITE 222MS, ON THE FEMALE THREADS OF BUTTON ASSEMBLY LEAVING THE FIRST AND LAST THREADS FREE. (FIGURE 1). **CAUTION: EXCESS LOCTITE CAN CAUSE THREADS TO LOCK VERY TIGHTLY, MAKING REPAIRS DIFFICULT.**

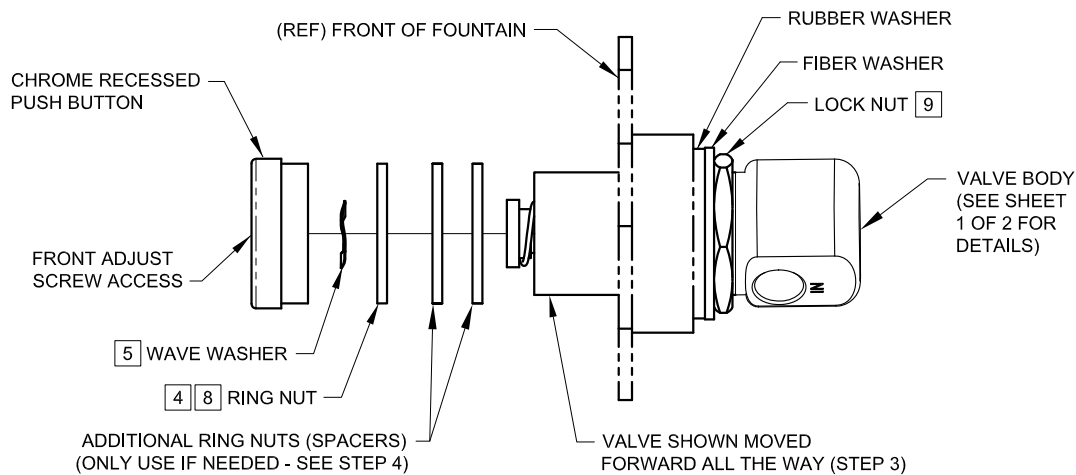
ASSEMBLED 5874PB  
(RECESSED MOUNT APPLICATION)

SEE SHEET 1 OF 2 FOR FLUSH MOUNT INSTRUCTIONS.

- \*\* OVERTIGHTENING WILL PRE-ACTUATE VALVE AND CAUSE WEEPAGE, WHILE NOT ENOUGH CONTACT BETWEEN WAVE WASHER AND STEM CAN CAUSE A LOW FLOW CONDITION.
